SWARTSWOOD LAKE DAM

NJ 00171

PHASE 1 INSPECTION REPORT NATIONAL DAM SAFETY PROGRAM

May, 1979

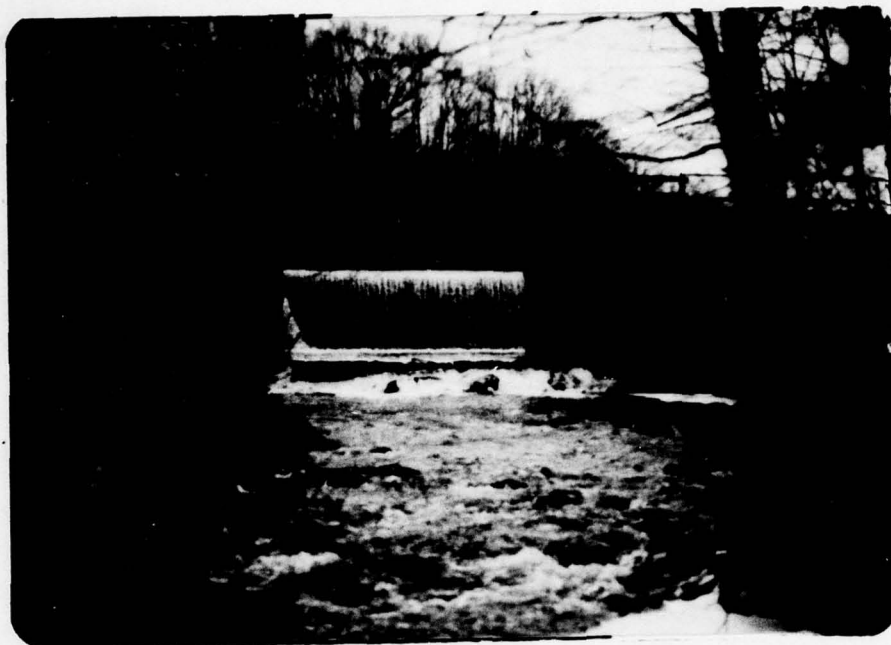
Masonry rock face of dam.
Looking upstream.

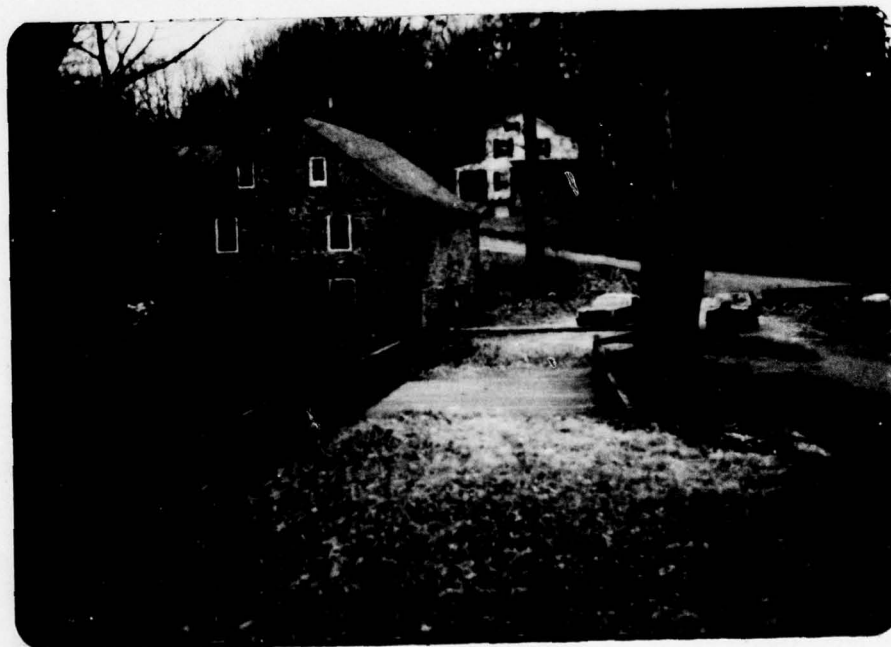
Abutments and roadway with wooden
bridge across dam. Looking west.

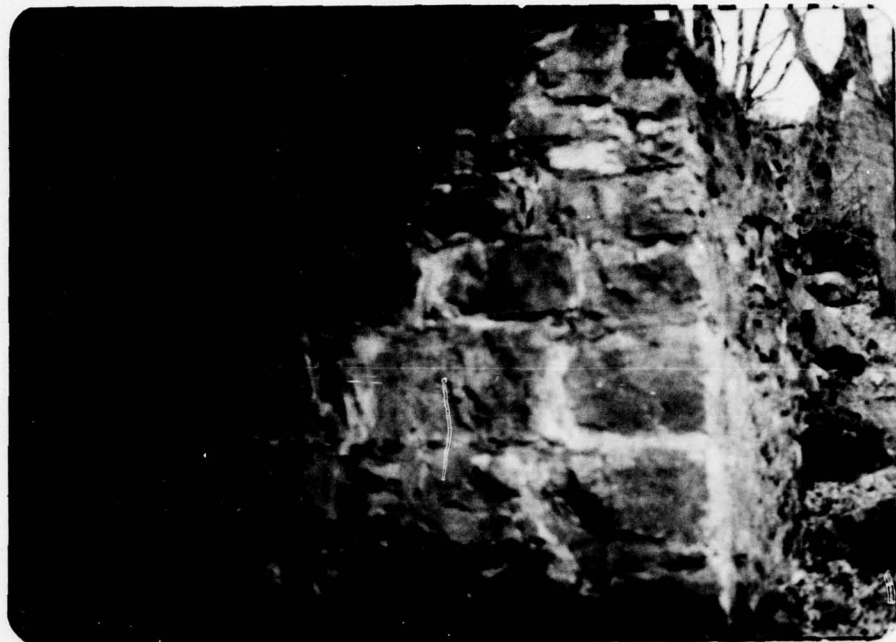
Left side of spillway discharge channel wall
and downstream face of dam. Looking east.

4. The spillway channel masonry sidewalls and the walls along the downstream face of the dam should be repaired and if necessary strengthened. This should be done soon.

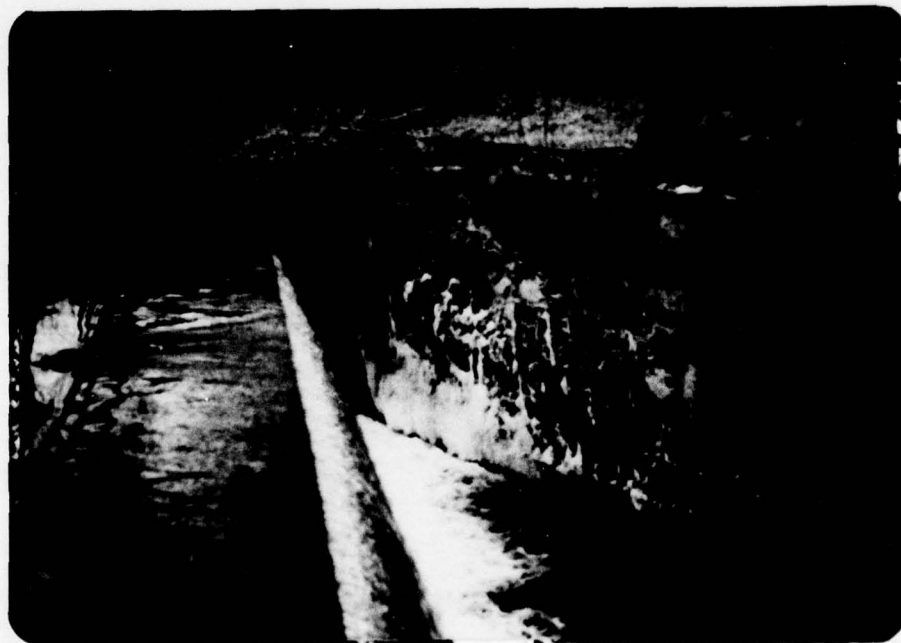
Crest of spillway and discharge channel
sidewall upstream of center of dam.
Looking east.

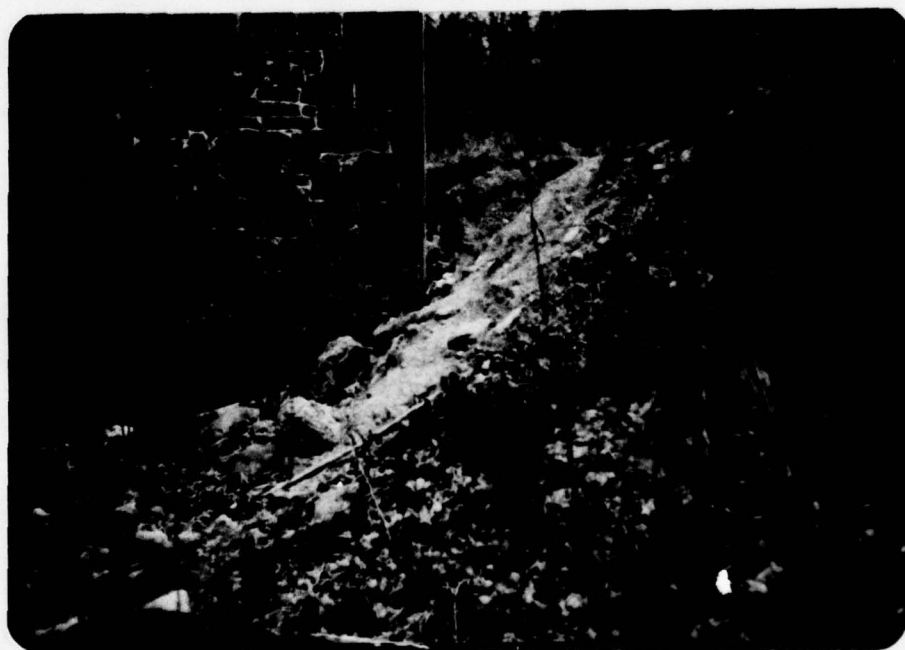
Erosion at downstream side of abutment.
(Historic Keens Mill House in background).

5. The erosion at the downstream side of the right abutment should be repaired. This should be done soon.
6. The hole at the downstream toe of the dam should be filled. This should be done soon.

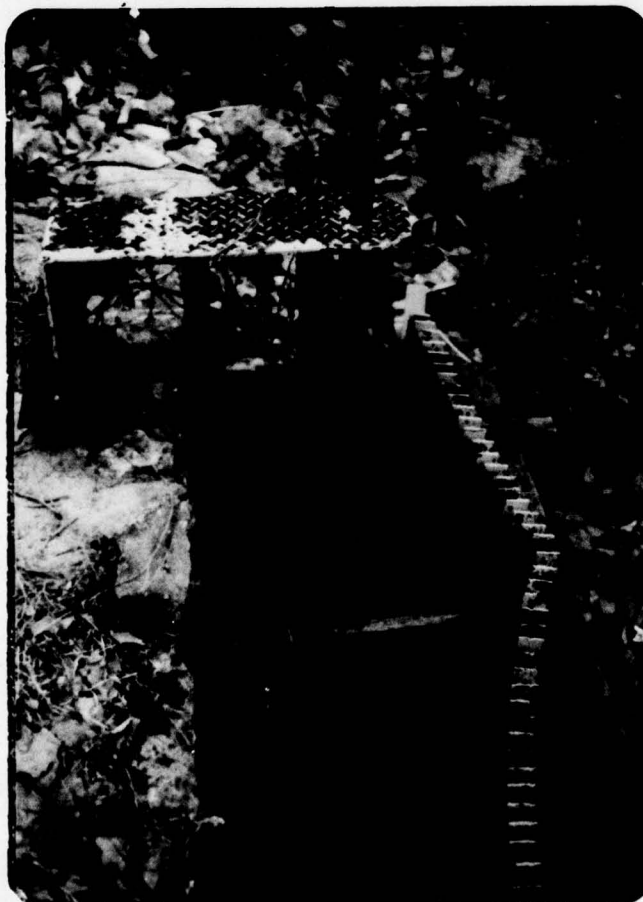
Trash rack and gate stem
no longer in use.

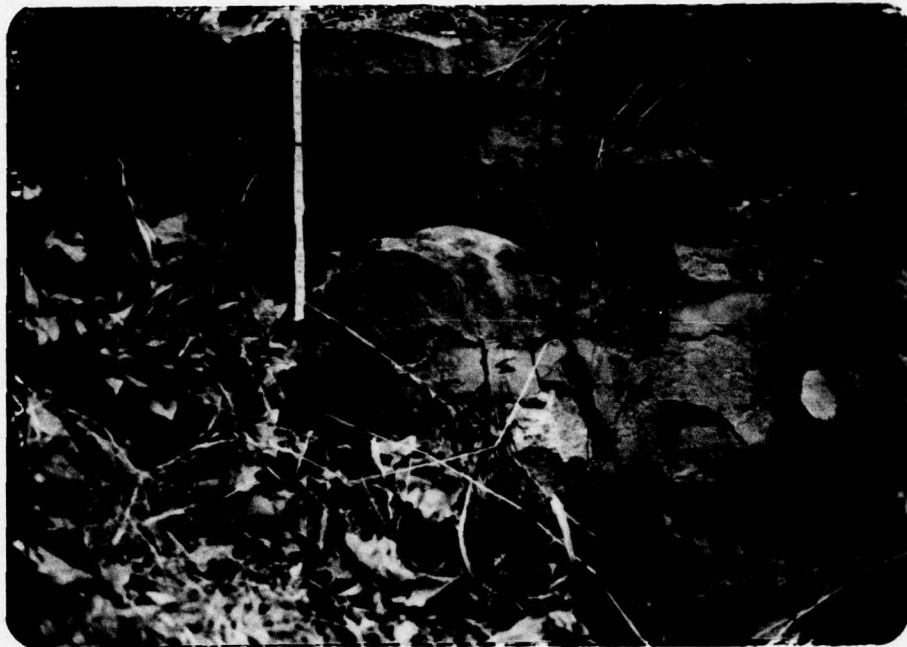
VISUAL EXAMINATION OF	OBSERVATIONS	REMARKS OR RECOMMENDATIONS
SURFACE CRACKS CONCRETE SURFACES	None observed other than cracks described below.	
STRUCTURAL CRACKING	Loose masonry on both ends of dam.	Voids around masonry should be filled.
VERTICAL AND HORIZONTAL ALIGNMENT	Appears satisfactory	
MONOLITH JOINTS	None Observed	
CONSTRUCTION JOINTS	Mortar cracks downstream face.

Deteriorated downstream face of masonry
of left abutment.
